TROUBLE SHOOTING, MICROMAX AND VVX MOTORS

Troubleshooting, MicroMax, MicroMax180, MicroMax370, MicroMax750

Connecting and troubleshooting VVX motors

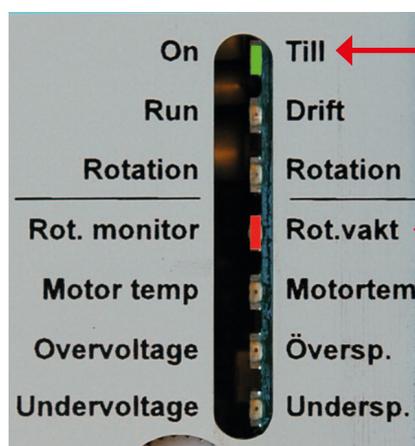
Control unit tripped due to rotation sensor

Probable cause during installation:

Magnet facing the wrong way (applies to IBC's magnetic sensor)

Magnetic sensor incorrectly connected (wrong polarity, applies to IBC's magnetic sensor) Connect the white cable to terminal 9, the Brown cable to terminal 10.

Probable cause during operation:

Broken belt

Belt slipping

Stuck wheel

Motor/Gearing damaged.

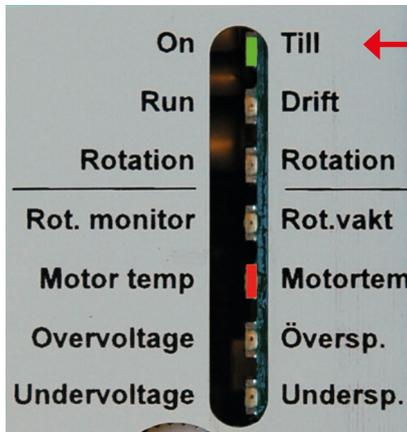
The motor temperature switch has tripped due to motor winding overheating

Probable cause:

Wheel rotation sluggish.

Bearing has seized; no oil.

Motor/Gearing damaged, e.g. bearing fault.

The motor temperature switch will revert to the default position when the temperature drops, but the alarm will remain in state and must be reset on the control unit.

If the control unit trips when the motor is cold, disconnect the cables to the magnetic sensor (T-T). Jump the terminals T-T and reset the control unit with the reset button.

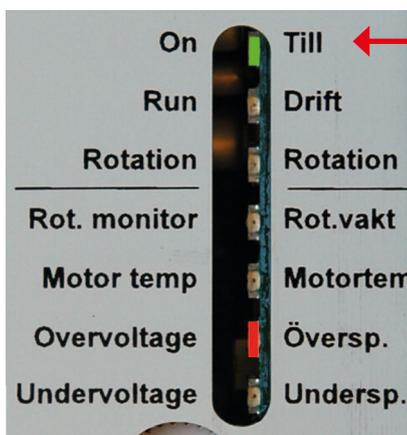
Overvoltage

Probable cause:

The power supply exceeds 276 V for more than 4-5 seconds, after which the control unit trips. Check the power supply.

If the voltage is correct, the control unit is defective.

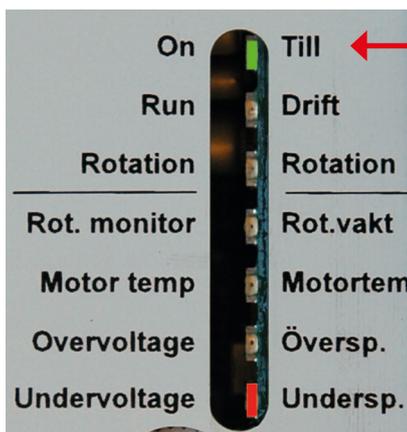
Undervoltage

Probable cause:

The power supply is below 195 V for more than 4-5 seconds, after which the control unit trips. Check the power supply.

If the voltage is correct, the control unit is defective.

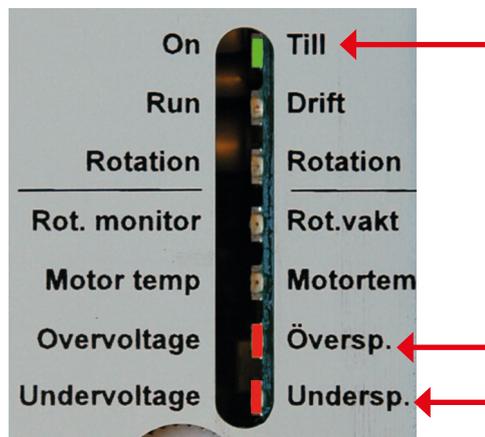
Overcurrent, Short circuit

When both the Overvoltage and Undervoltage indicators are lit, it indicates overvoltage or a short-circuit.

Overcurrent The control unit limits current and trips after 4-5 seconds. Probable cause:

Phase-to-phase short circuit: The control unit limits current and trips after 4-5 seconds. Probable cause:

Phase-to-earth short circuit (earth fault). The control unit trips immediately. Probable cause:

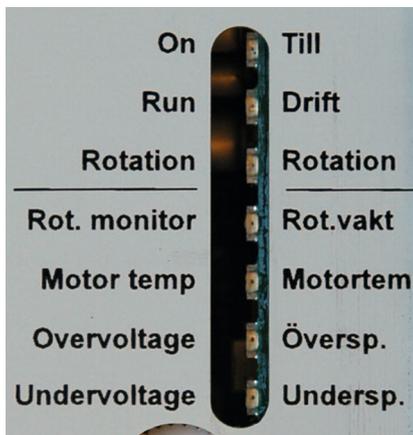
No LED lit

Probable cause:

Measure the power supply on terminals L and N; should be 230 V.

If the voltage is as above, check the fuse in the control unit.

If the fuse is intact, the control unit is defective.

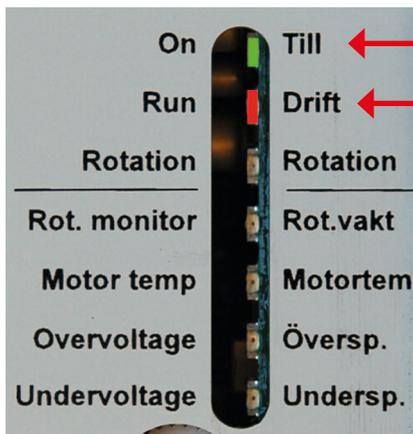
The wheel rotates despite a 0% input signal from the control unit

Probable cause:

In certain cases the control unit may give residual voltage even though it should be at 0.0 V.

Measure the voltage across terminals 2-3; it should be below 0.07 V for the control unit to switch off.

Check that the High Speed and Low Speed DIP switches are set to OFF.

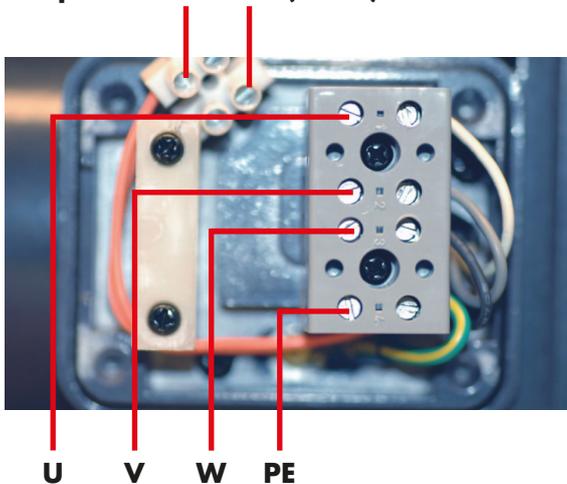
Connecting a three-phase geared motor

Temperature switch (T – T)

VVX motors with outputs of 25, 40 and 60 W are geared motors designed for 3x230 V. They cannot be rewired for 3x400V.

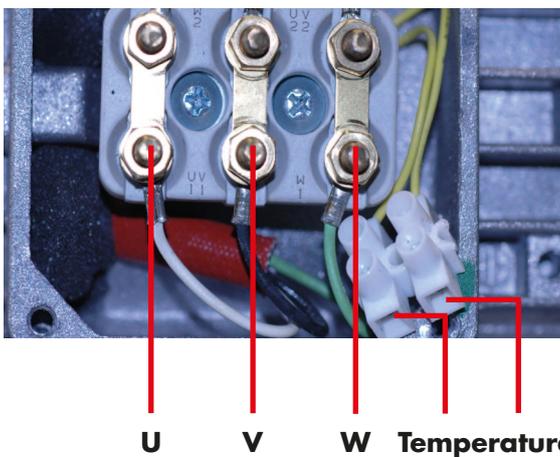
Connecting a three-phase worm gear motor

VVX motors with outputs of 90, 180, 370 and 750 W are worm gear motors designed for 3x230/400 V (Star/Delta).

On delivery from IBC, the motors are Delta wired, i.e. wired for 3x230 V. This is often referred to as 111 wiring as the three connections resemble three numeral 1s side by side.

All of the motors have temperature switches wired to a terminal block for onward connection to the control unit. Note that it is the control unit that cuts power via the temperature switch if the motor overheats.

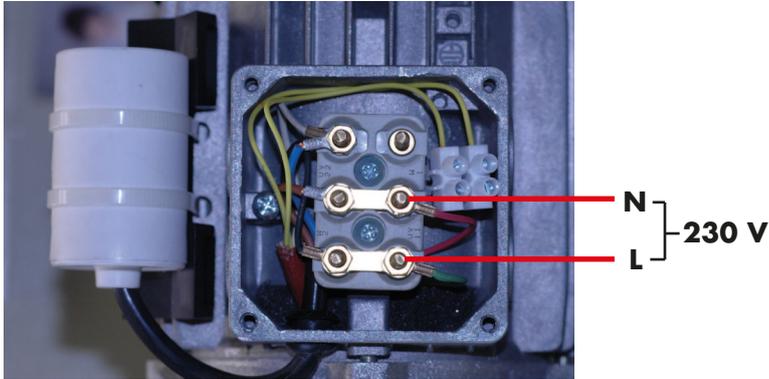
Connecting a single-phase worm gear motor

Motors controlled by MicroStart are single-phase motors wired for 1x230 V. An operating capacitor is used to assist start. The capacitor is located either in the MicroStart control unit or the motor. Also refer to the MicroStart connection instructions.

In most cases there is also a temperature switch wired to a terminal block. *Not illustrated.*

Alternatively, a thermal circuit breaker aka a klixon is installed in the winding. This cuts power in the winding and the motor stops. When the motor cools, the circuit is closed again.

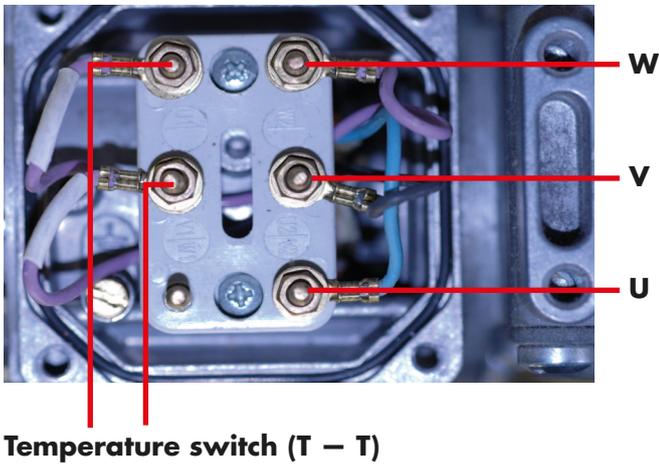
Connecting a three-phase GEFEG motor

Previously, IBC used three-phase motors made by Gefeg. These motors are wired as illustrated on the left.

It is unclear how a replacement motor if any will be wired; refer to the wiring alternatives above.

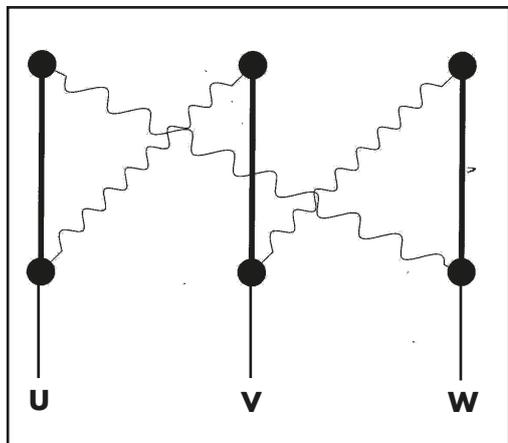
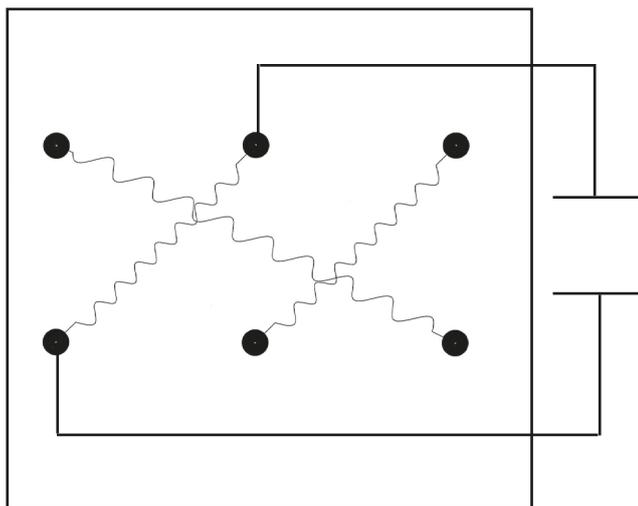
Measuring motor winding resistance

Tests should be performed using a Megger or a universal instrument to make sure that the motor windings are intact.

Measuring resistance

Before the test is carried out, the motor cables must be disconnected and the connection links in the motor removed.

Resistance should be identical on all three phases.

Measure motor resistance; it should be identical on all phases. (See page 8).
